**US Army Corps
of Engineers®**
Buffalo District

Cayuga Creek, Niagara County, New York

Flooding and Related Water Resources

Section 905(b) (WRDA 86) Analysis Reconnaissance Report

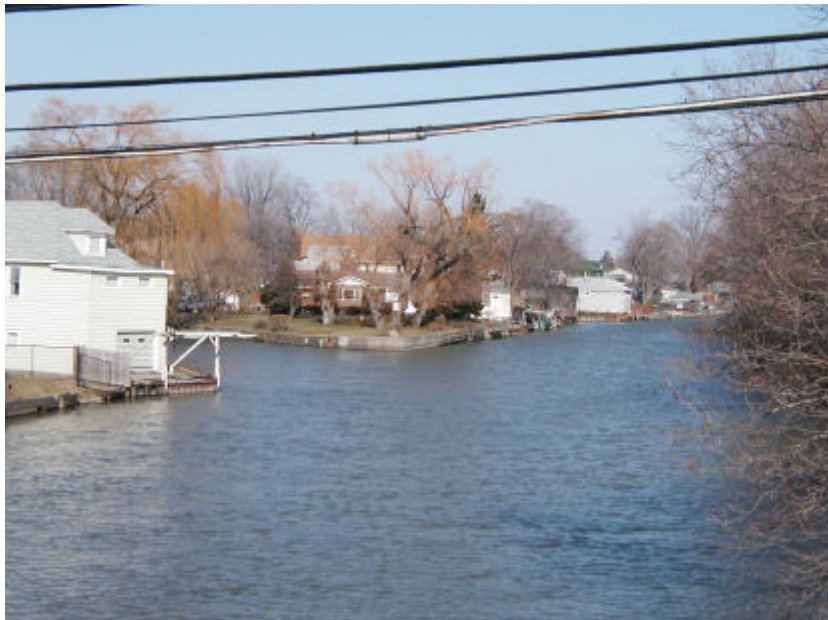
Photo. Exhibit 1: Northeast facing view of the mouth of Cayuga Creek (shown at left) at the Little River in the City of Niagara Falls from the S. 86th Street bridge (February 2002).

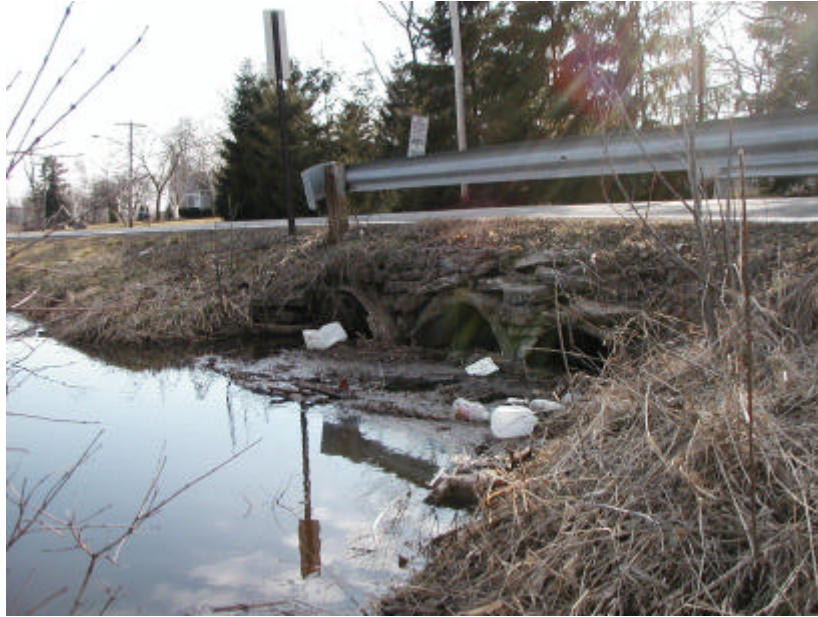
Photo. Exhibit 2: Culverted crossing of Cayuga Creek under Walmore Road north of Lockport Road in the Town of Wheatfield (February 2002).

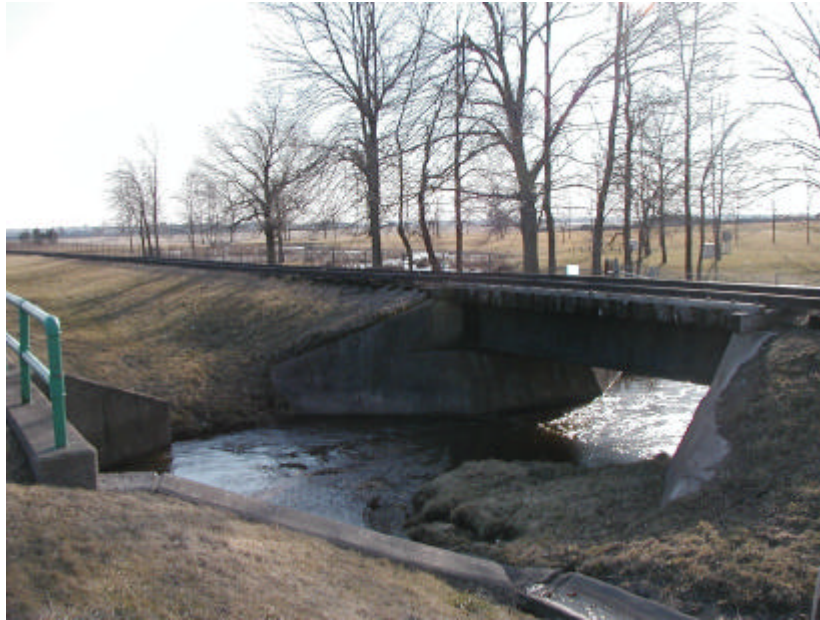
Photo. Exhibit 3: Southwest facing view of Cayuga Creek flowing onto the airport-air base complex under Walmore Road bridge and railroad bridge in the Town of Wheatfield (February 2002).

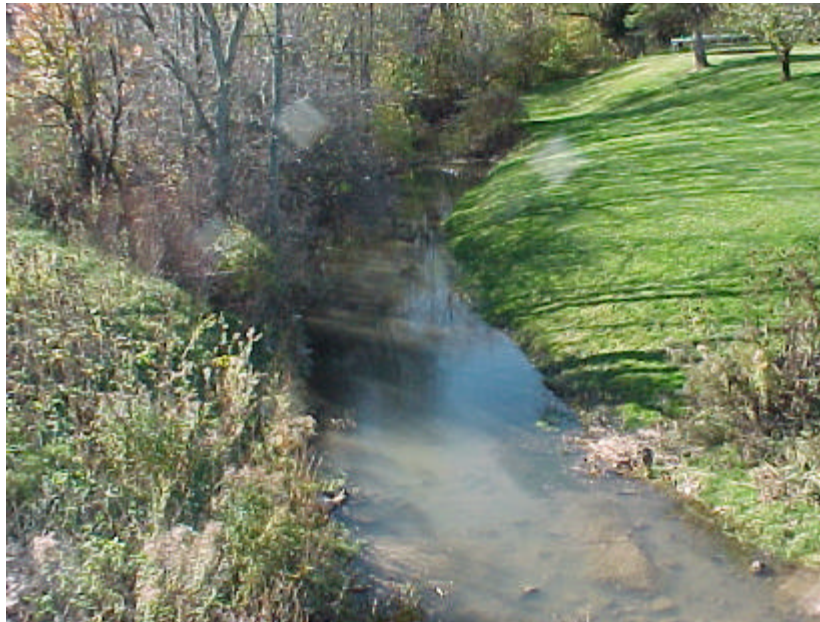
Photo. Exhibit 4: South facing view of Cayuga Creek immediately south of the Porter Road bridge (September 2001).

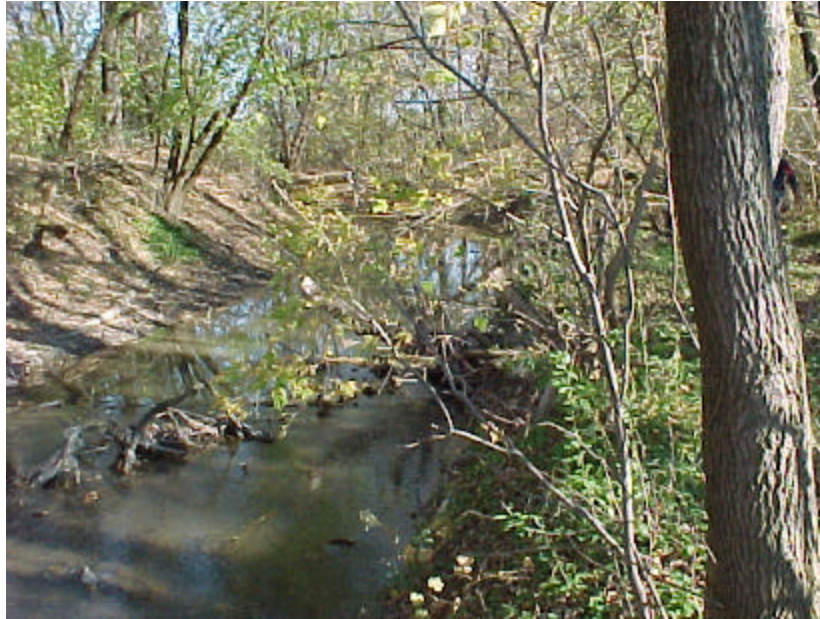
Photo. Exhibit 5: View of typical Cayuga Creek channel conditions in the Town of Niagara along the “farmer’s field” in the study focus area just south of Porter Road (September 2001).

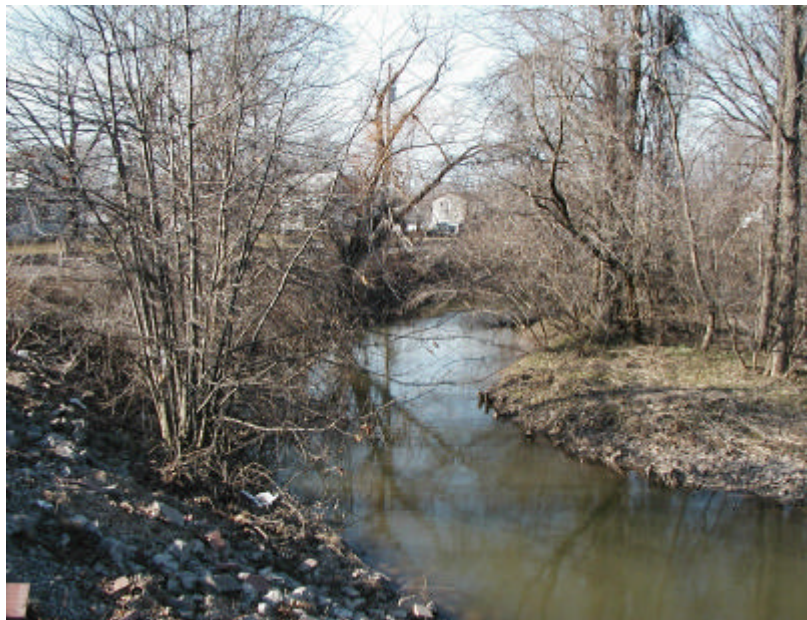
Photo. Exhibit 6: Northwest facing view of meandering segment of Cayuga Creek along Tuscarora Road south and west of the Cayuga Village Trailer Park and north of Niagara Falls Boulevard in the Town of Niagara. Note residential development along the west bank (February 2002).

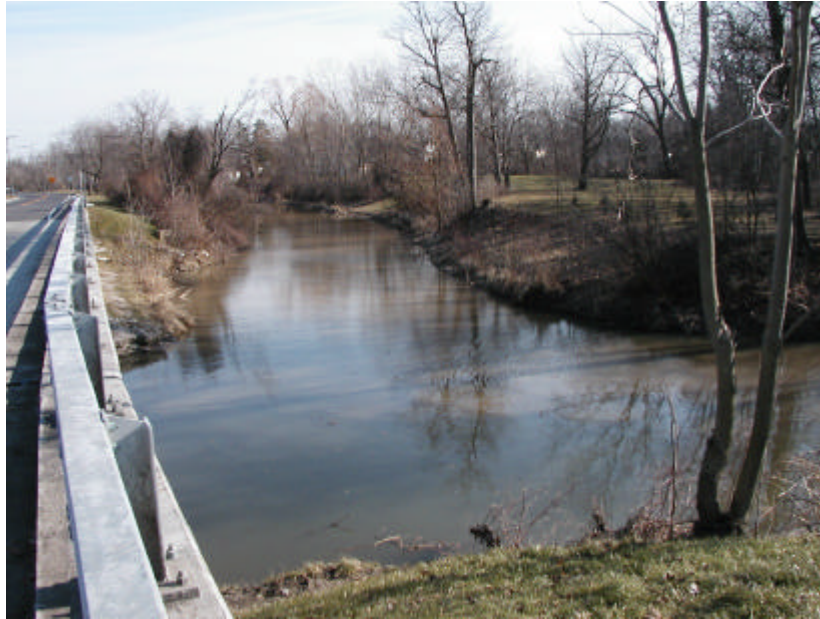
Photo. Exhibit 7: West facing view of Cayuga Creek confluence with Bergholtz Creek immediately south of the Cayuga Drive bridge in the City of Niagara Falls (February 2002).

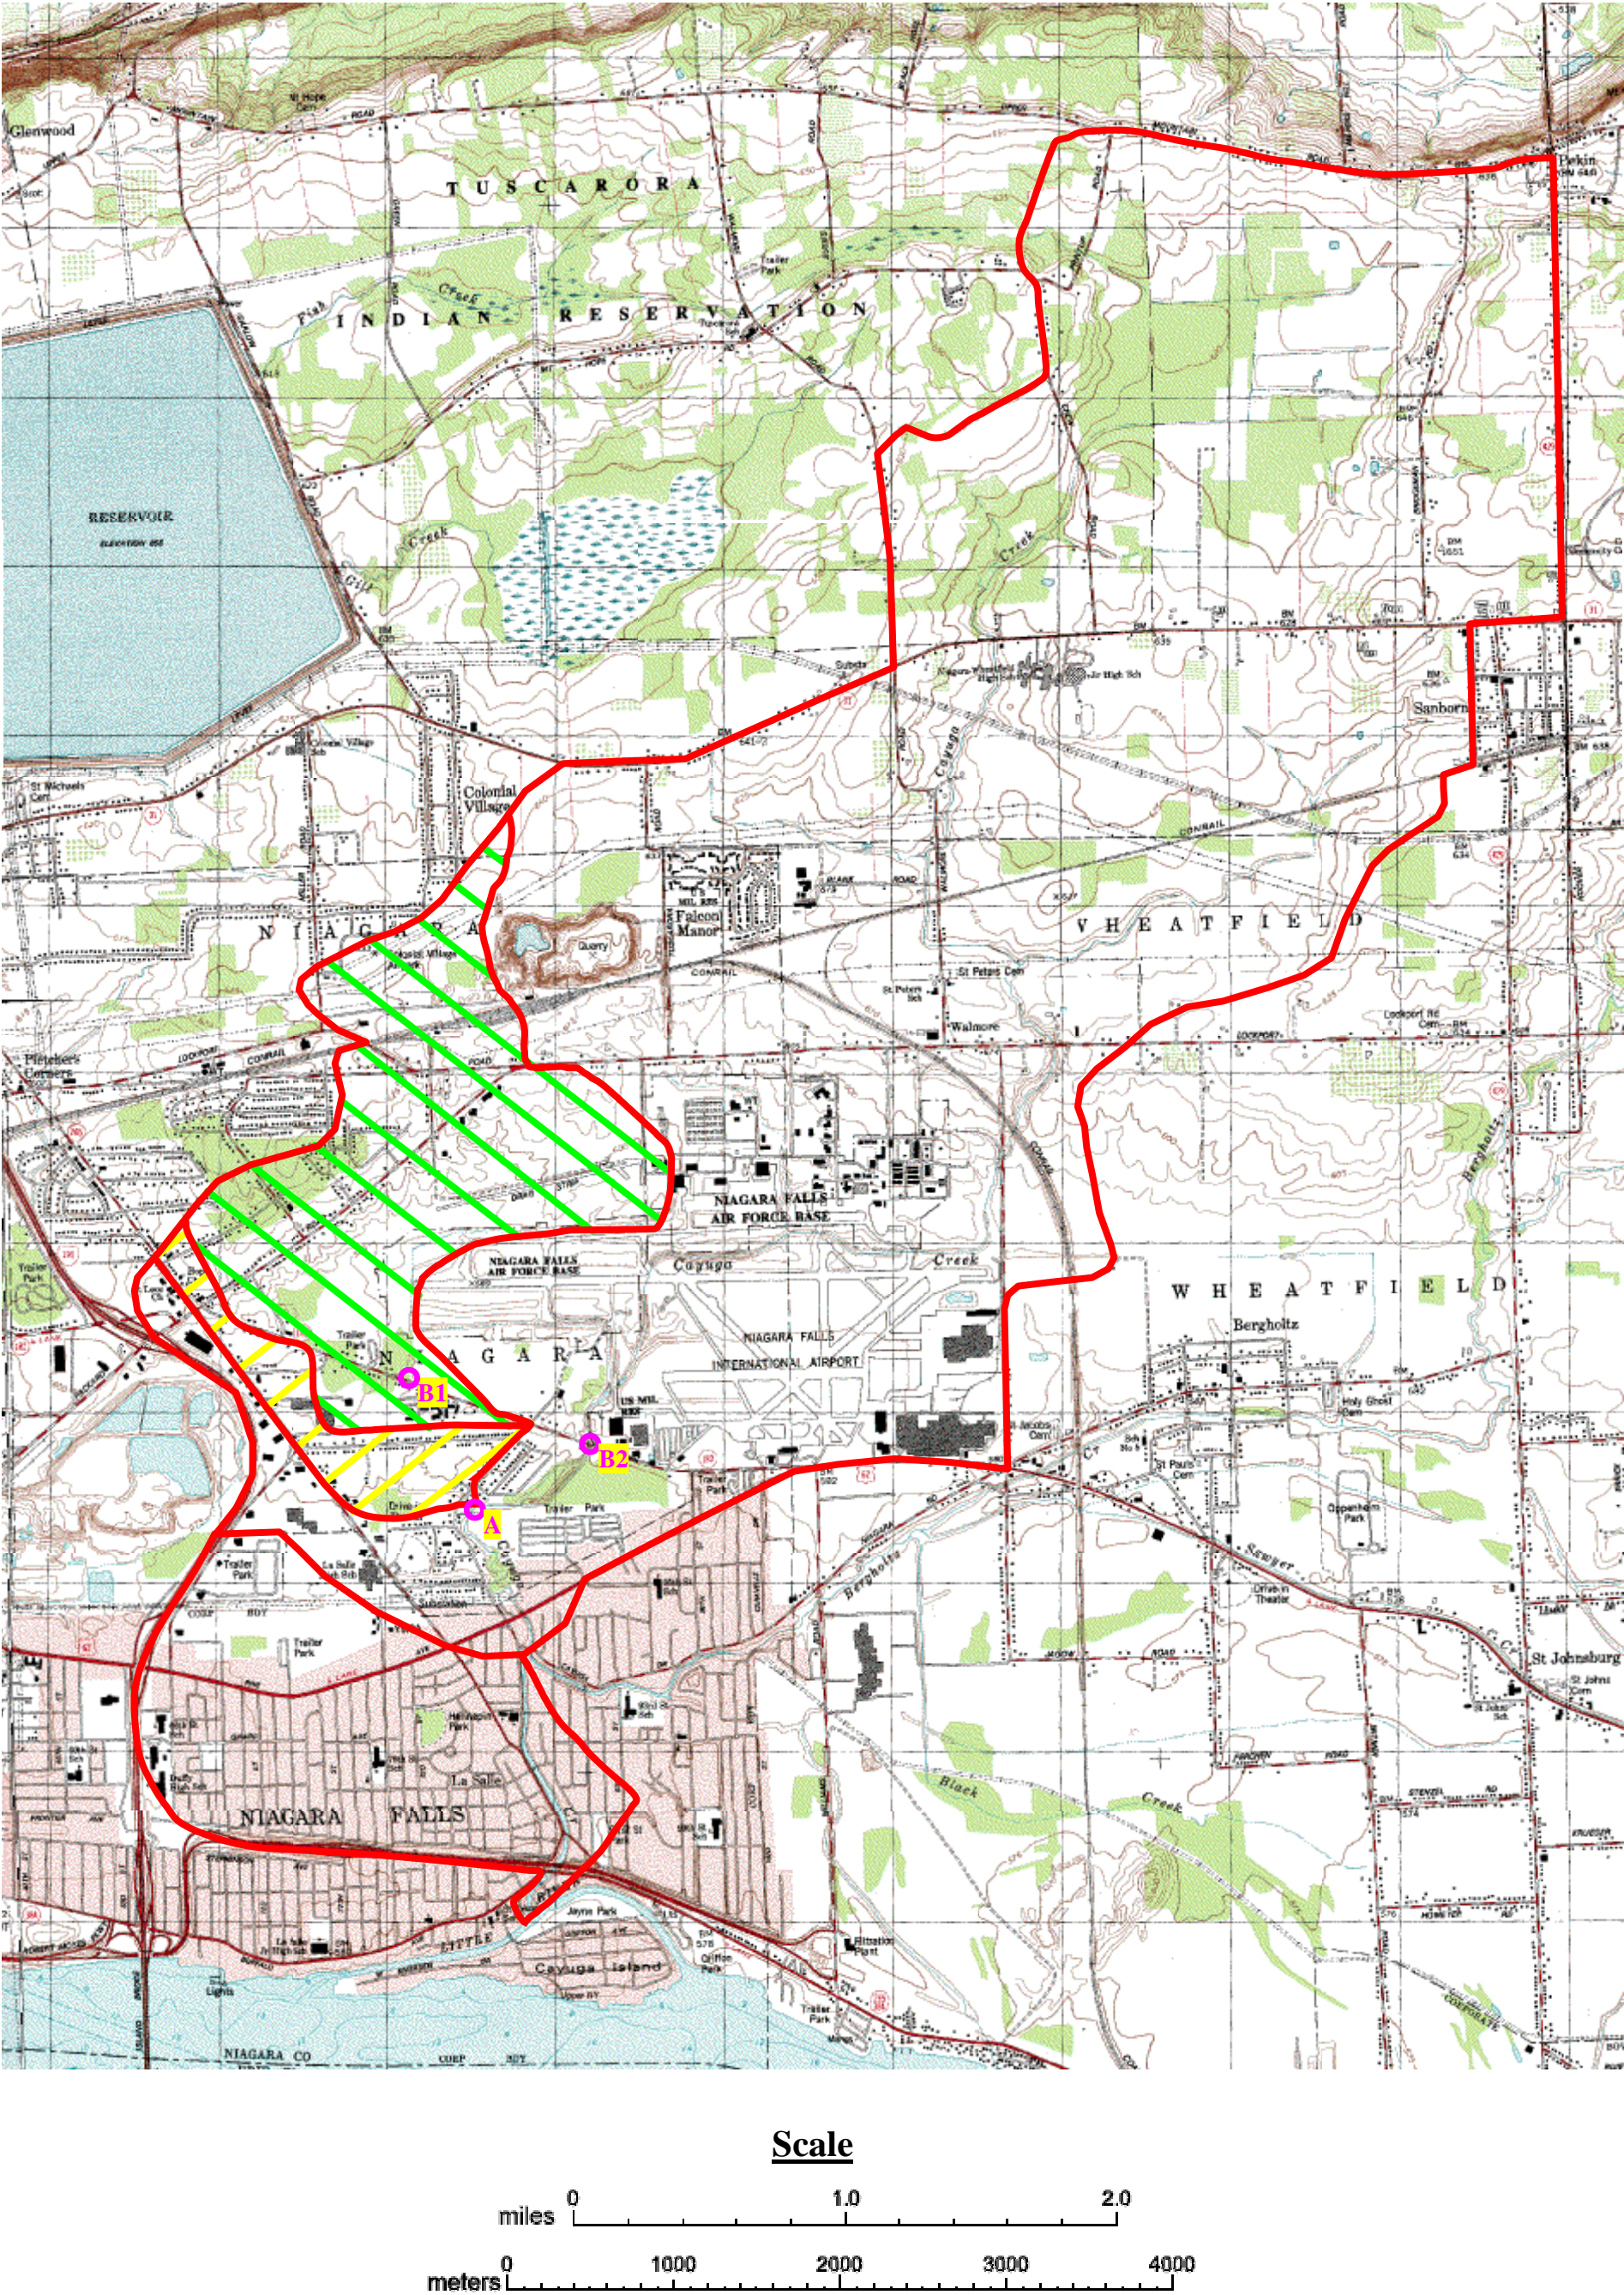
Figure 7: West Branch Tributary Basin.

The current hydrologic model has a 10-yr. discharge of 1010 cfs at the West Branch Tributary outfall on Cayuga Creek (location B2 on Figure 7). If the West Branch Tributary were not a contributing factor at Porter Road, the discharge for the 10-yr. event at location B2 would be around 730 cfs, which represents a 280 cfs difference in discharge. The remaining 0.37 square mile West Branch Tributary basin (highlighted in yellow) has been developed quite extensively within the past 20+ years and the once open channel is now routed through a culvert and discharges into Cayuga Creek at location A.

The 1965 Tonawanda West and Ransomville USGS Quadrangles show the West Branch Tributary basin as originally being 2.15 square miles and discharging into Cayuga Creek via an open channel just south of Lozina Drive (location A on Figure 7). Presently, a 1.79 sq. mile portion of the West Branch Tributary basin is diverted through a culvert beginning at Porter Road (location B1 on Figure 7), which then discharges into Cayuga Creek at Porter Road (location B2 on Figure 7), approximately 2800’ further upstream than its original location. There has also been some development in the basin along Packard Road and Porter Road that could lead to higher discharges.

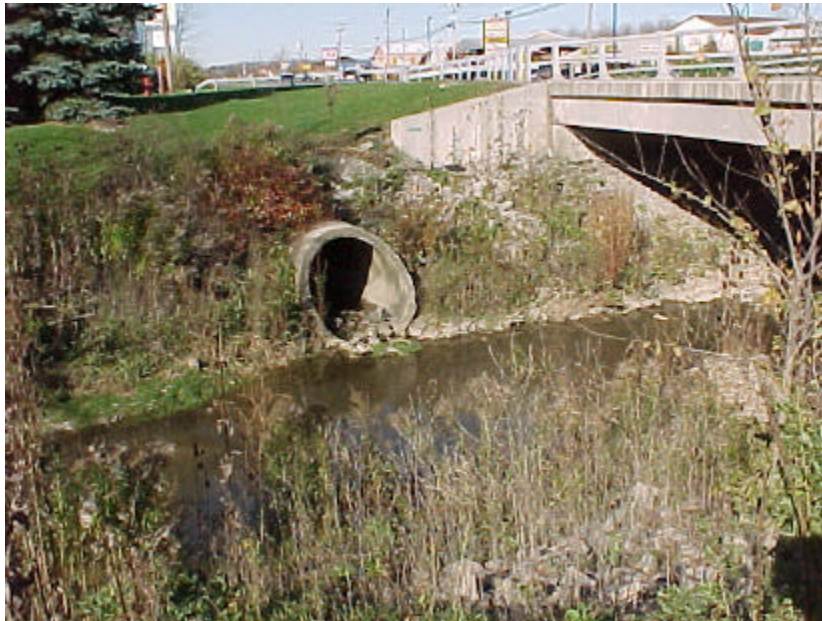
Photo. Exhibit 8: The West Branch Tributary discharge pipe shown facing west northwest immediately south of the Porter Road bridge in the Town of Niagara (September 2001).

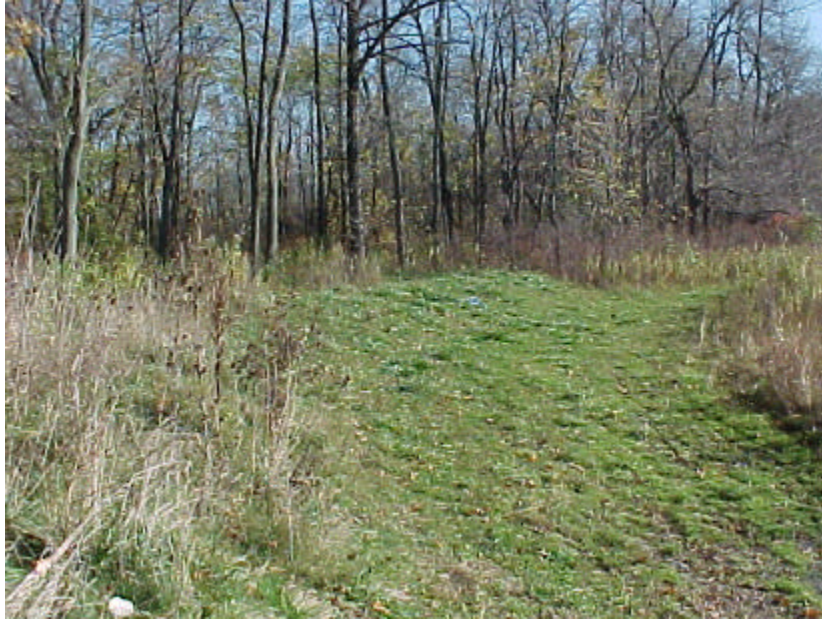
Photo. Exhibit 9: Northeast facing view of the north end of the existing earthen berm along Cayuga Creek adjacent to the “farmer’s field” in the Town of Niagara (September 2001).

There is an existing old earthen levee (berm) that defines the east and south banks of Cayuga Creek as it flows through the area immediately north of the trailer park (Figure 6). This structure is suspected to be the remains of an old levee that was constructed to protect open space east of the levee referred to as the old "farmer's field". This levee, as it currently exists, is approximately 300 feet short of connecting with the elevated roadway known as Porter Road (Route 182) and, therefore, fails to maintain a continuous level of containment. The old farmer's field is approximately 30-36 acres in size and has functioned in the past as a retention basin to reduce the severity of flooding. Time and development in the surrounding landscape, however, has reduced the farmer field's effectiveness for flood water storage.

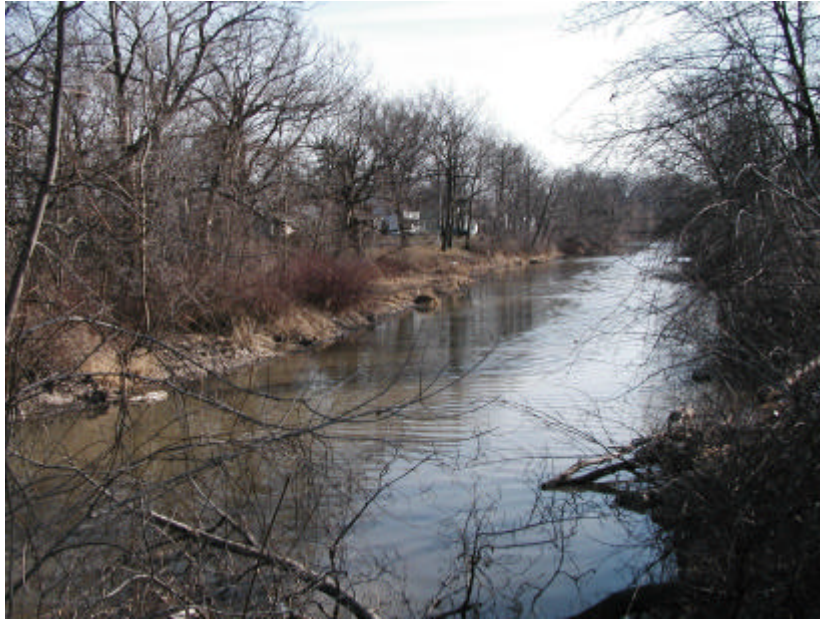
Photo. Exhibit 10: South facing view of emergent wetland along the east bank of Cayuga Creek just downstream of the confluence with Bergholtz Creek in the City of Niagara Falls (February 2002).

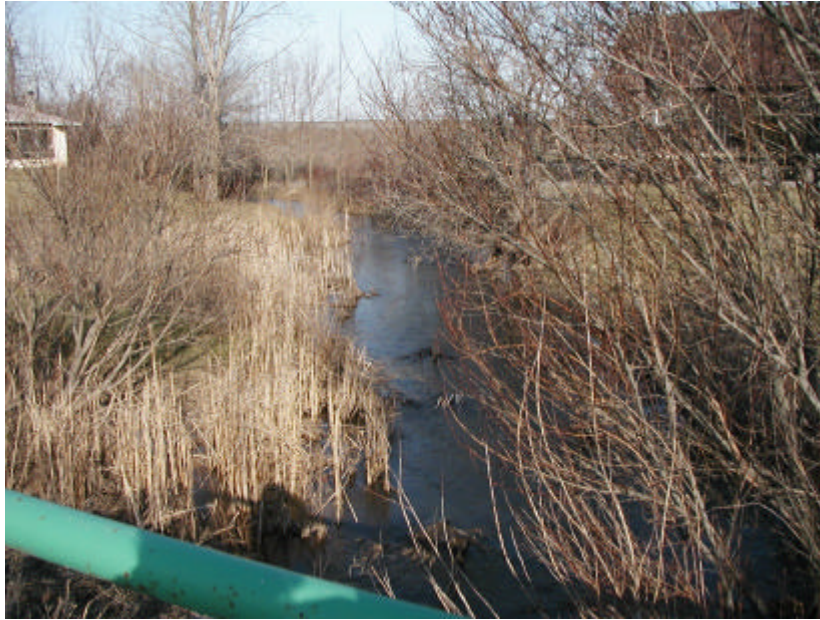
Photo. Exhibit 11: Small area of emergent wetlands associated with Cayuga Creek on the west side of the Walmore Road bridge in the Town of Wheatfield (February 2002).

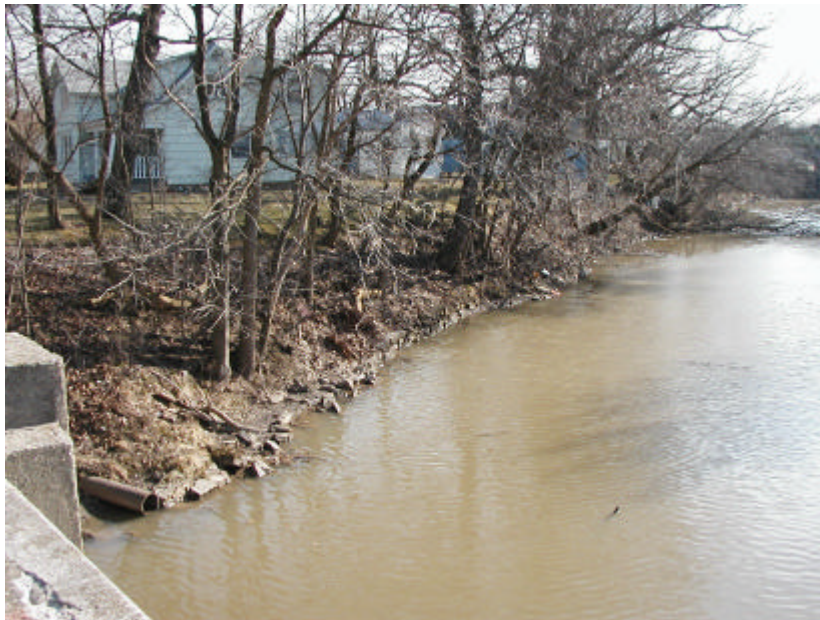
Photo. Exhibit 12: Southeast facing view of the east bank of Cayuga Creek at the Milestrip Bridge in the City of Niagara Falls. Note the turbid water conditions, discharge pipe and poor shoreline conditions (February 2002).

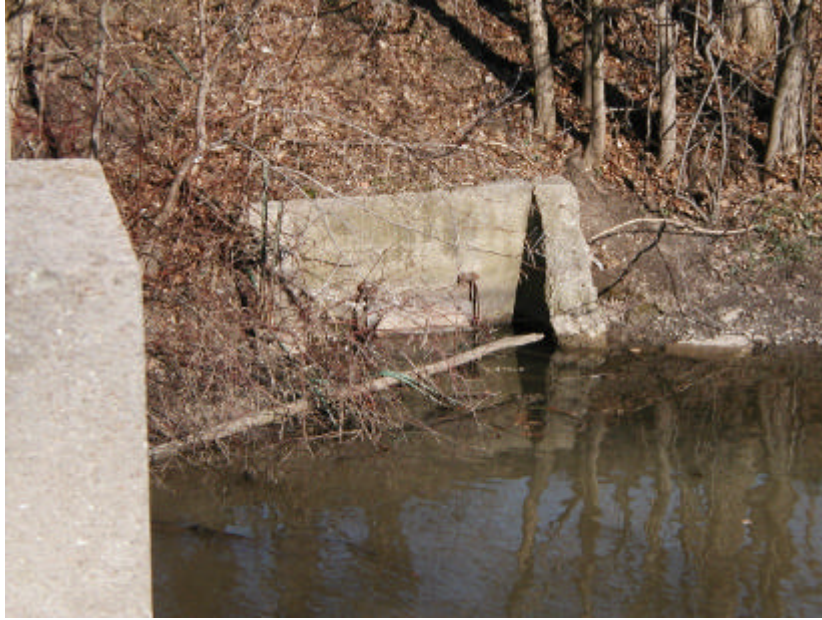
Photo. Exhibit 13: Storm sewer outfall into Cayuga Creek at the Lindbergh Avenue bridge in the City of Niagara Falls (February 2002).

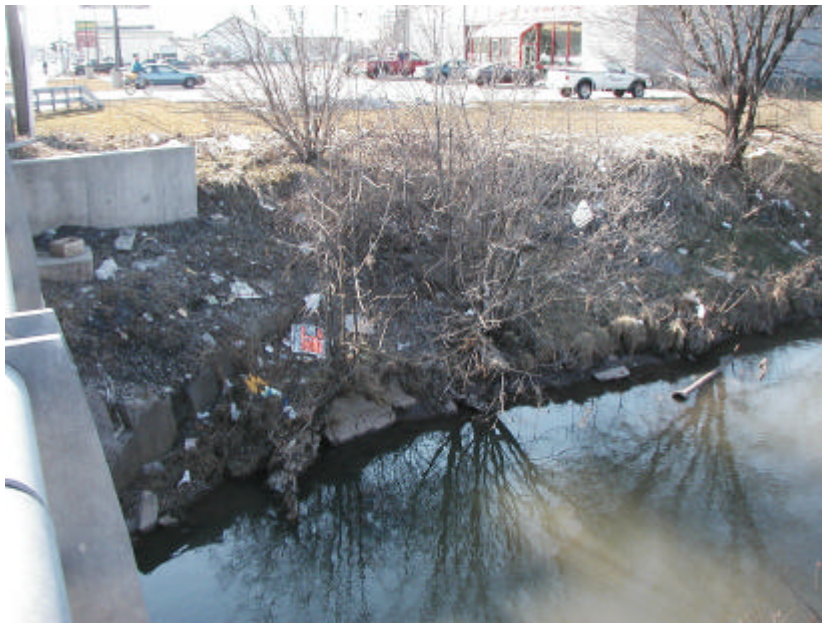
Photo. Exhibit 14: Typical view of the junk and debris that commonly occurs along the banks of Cayuga Creek and degrades many aspects of the creek including water quality, habitat, and aesthetics. This image was taken north of the Niagara Falls Boulevard bridge in the City of Niagara Falls (February 2002).

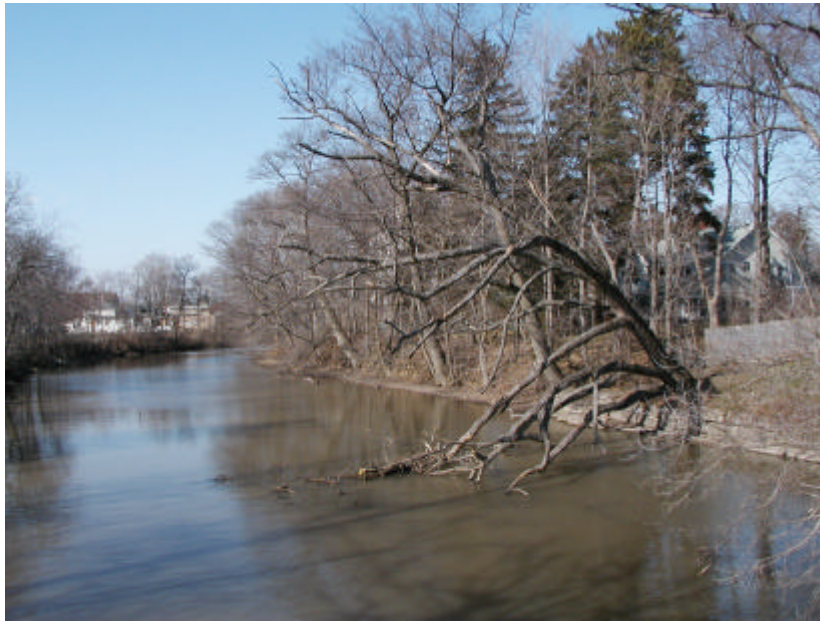
Photo. Exhibit 15: North facing view of fallen tree along unstable shoreline in the City of Niagara Falls at the Lindbergh Avenue bridge. Unstable shoreline causes loss of valuable trees and riparian habitats and dead fall such as this can cause obstructions to flow (February 2002).

Stream bank and channel erosion and the resulting suspension of sediment are significant and recognized problems throughout the watershed, particularly within the City of Niagara Falls. The constriction and concentration of creek flows, channel modification, concentrated point source discharges, loss of woody riparian vegetation, altered hydrologic characteristics, and fluctuations in water levels associated with Power Authority of the State of New York management of the Niagara River are contributing causes to this problem. Stream erosion continues to reduce the quantity and quality of the shoreline, the water column, vegetated shallows and the riparian corridor and overhanging trees and shrubs, which is subject to undercutting and deadfall.

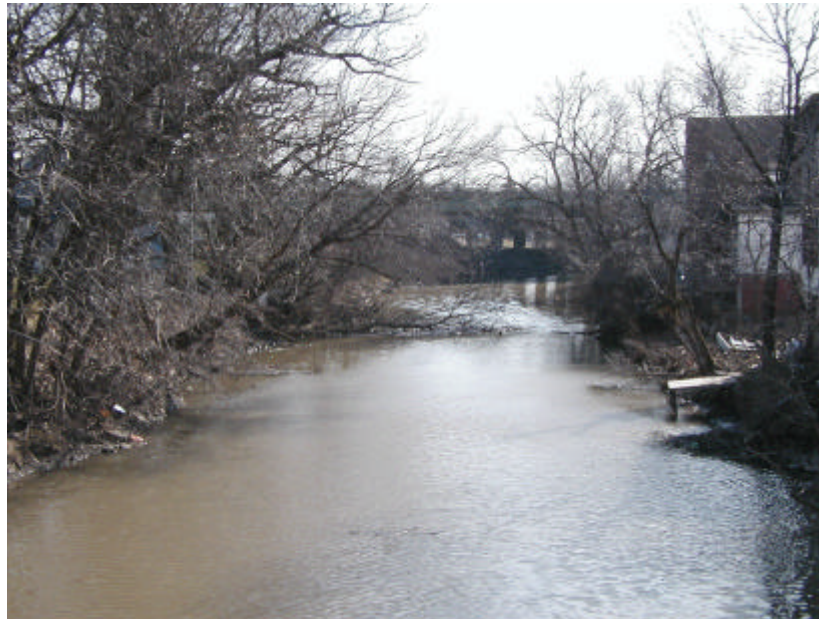
Photo. Exhibit 16: South facing view of dead fall and degraded shoreline conditions in the City of Niagara Falls from the Milestrip Road bridge (February 2002).

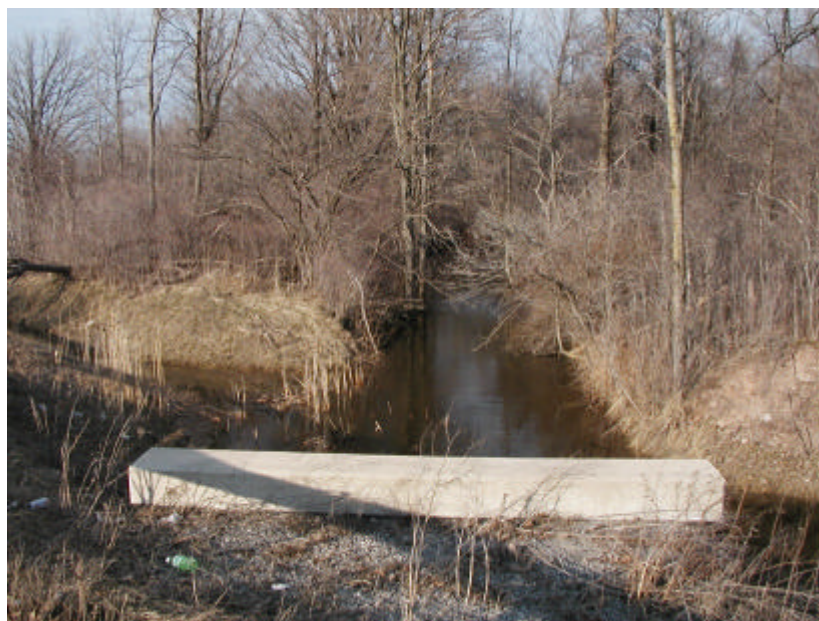
Photo. Exhibit 17: View of Cayuga Creek near its headwaters immediately Northeast of Chew Road on the Tuscarora Reservation. Note the relatively narrow channel and wooded riparian conditions (February 2002).

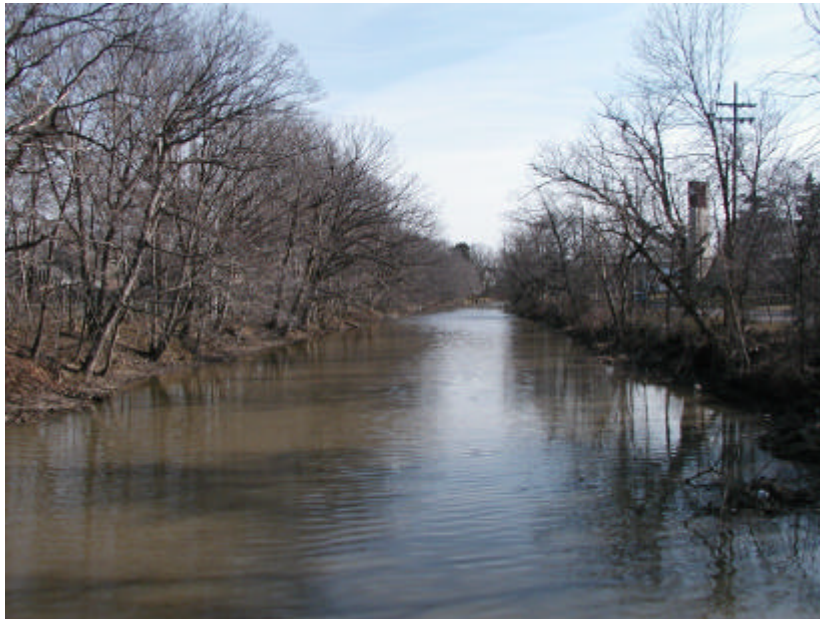
Photo. Exhibit 18: South facing view of Cayuga Creek from the Lindbergh Avenue bridge in the City of Niagara Falls. The location is downstream of the Bergholtz Creek confluence less than 1 river mile from the mouth in the City of Niagara Falls. Note the change in channel conditions compared to Photo. Exhibit 14 (February 2002).
